2022 Chevy Truck Silverado 1500 4WD V8-6.2L

#PIT6473E: Service Forward Collision / Forward Collision Unavailable Messages / Automatic High Beams Inop / Camera Only Learns to 94% / U3000 - (Mar 24, 2026)

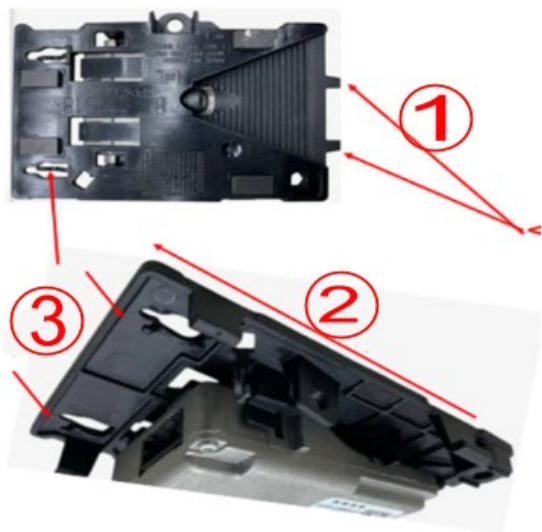
1) Alignment tabs

2) Push in direction of arrow to release lift tabs

3) Lift tabs

STEP 2. Remove B174W FVCM brackets from interior windshield (refer to pictures below).

STEP 8. Reinstall the FVCM bracket, FVCM, mirror and trim. (review and inspect the FVCM tabs to ensure they are properly seated).
